Project: Crestlake Subdivision – Detention Basins

(CDI Project No. C2190010)

Date: December 28, 2022 **Subject:** Sedimentation Study

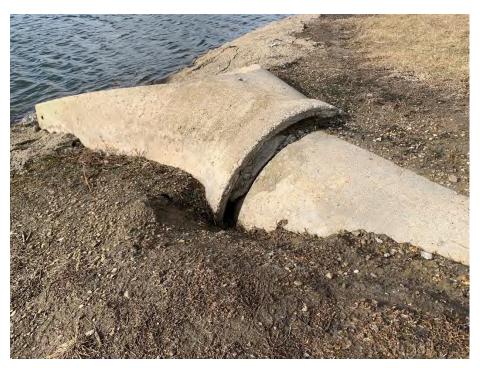
The basin inlet and outfall structures appear to be free from debris and performing as expected. It is recommended that the 27" flared end section located in the center of the northeast area of Basin 1 be repaired. The pipe is separated from the end section with some erosion and is a potential safety hazard as shown in Figure 2.

Figure 2. Basin 1 Flared End Section Photo
