Project: Crestlake Subdivision – Detention Basins

(CDI Project No. C2190010)

Date: December 28, 2022 **Subject:** Sedimentation Study

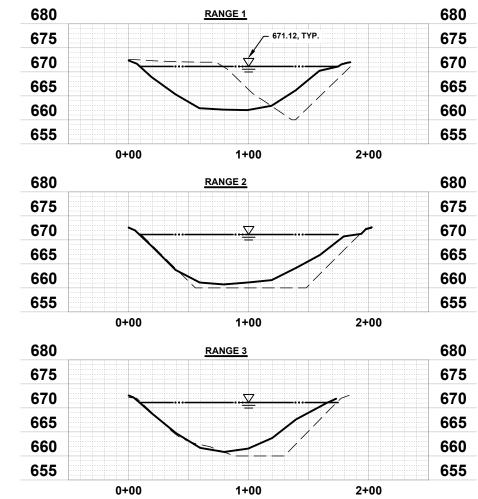
POND 2

Average sediment depth for the basins is summarized in Table 2. Similar studies have shown that urban detention basins typically accumulate sediment at a rate of 0.1 to 1.0 inches per year and require sediment clean out on a 15 to 25 year cycle¹. The basins' sediment accumulation rates were found to be reasonable based on this information. Ponds 3 and 4a have very slow accumulation rates. Ponds 1 and 4b have low to medium accumulation rates. Ponds 2 and 5 have higher accumulation rates.

However, it is recommended to evaluate the sediment in at least Ponds 2 and 5 again in 10-15 years to confirm if they are experiencing the apparently high deposition rate. The reduction in volume is not a concern at the present time since the sediment accumulation rate is still within the expected range. Future analysis will be able to be analyzed more confidently as this field data is likely more accurate than the as-built plans used as a reference for the original basin floor surface.
